POST OF 22/08/2026

## Combustion chamber acceptance: the 10 inspection points

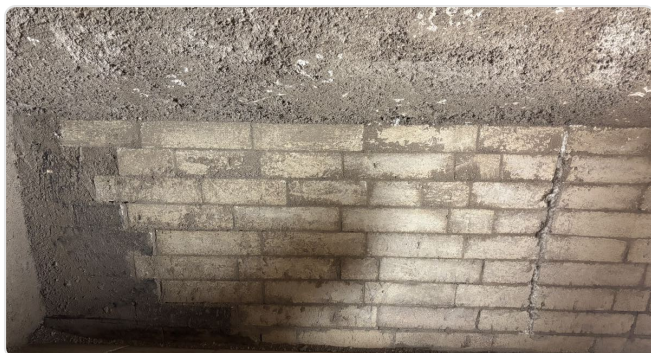
*Stepped, interlocking transition, expansion joint on the right*

That is why fired brick in a tight stretcher bond belongs above the grate, monolithic castable above that for corners, inclines and penetrations — and the boundary between the two runs as an interlocking stepped line, never as a straight one.

| <input type="checkbox"/> <b>Brick/castable transition</b> | runs as an interlocking stepped line, every step offset — no continuous horizontal line |
| <input type="checkbox"/> <b>Vertical expansion joints</b> | continuous from bottom to top, not offset — otherwise the force is still transmitted through the bricks |

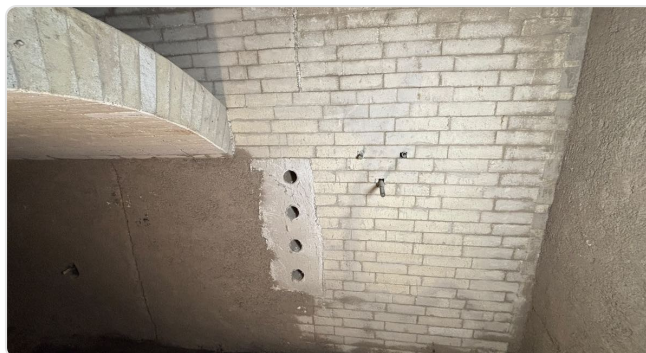
*Secondary air openings set during installation*

| <input type="checkbox"/> <b>Secondary air openings</b> | set cleanly within the bond, closed edge — not drilled afterwards |
