POST OF 06/07/2026

## Expansion joints: the most inconspicuous cause of damage

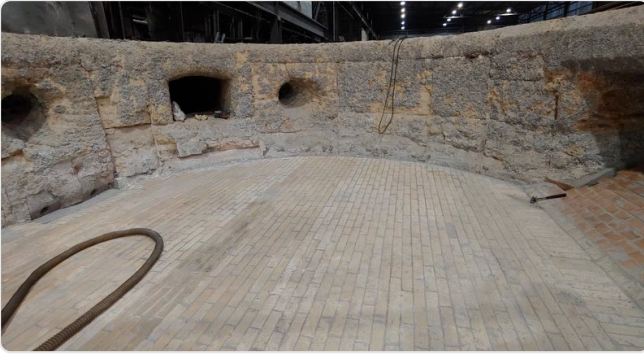
*The least conspicuous cause of refractory damage*

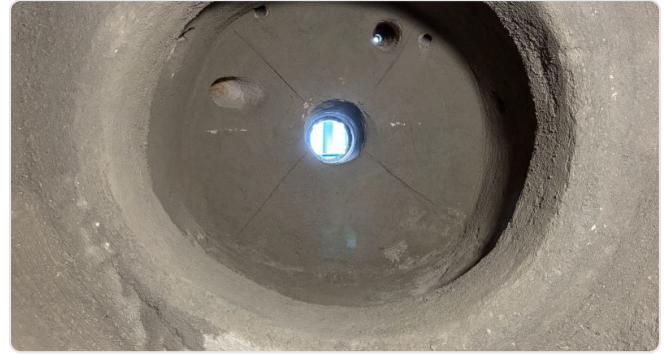
*Expansion joint properly packed with fibre blanket*

- ☐ **Continuously vertical** from bottom to top in one line — offset joints still transmit the force through the bricks
- ☐ **Packed with fibre** ceramic fibre yields and still seals against flue gas — mortar makes the joint useless
- ☐ **Width calculated** from the expansion of the selected material at operating temperature — not taken over as a rule of thumb
- ☐ **Correctly placed** at structurally quiet points — not in corners, not next to penetrations
- ☐ **Maintained** check at every turnaround: compacted or slagged joints no longer work
