POST OF 06/09/2026

## Flame pattern and burner control: Where the flame impinges

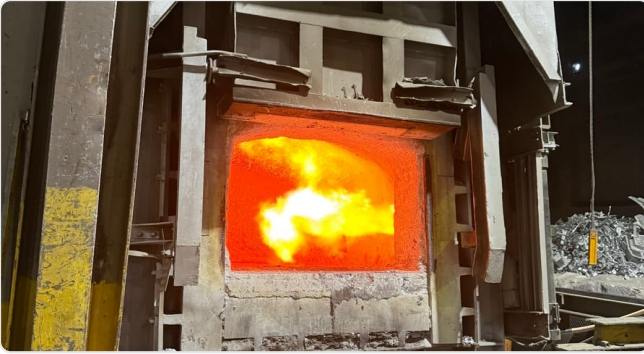
*Flame in the furnace chamber — what matters is where it impinges*

A furnace rarely wears where the heat is generated, but where the flame impinges. If it strikes the lining directly, it burns a wear pocket into an otherwise sound wall.

The burner block reveals the setting. That is why the burner axis and the opposite wall are inspected together — the damage is almost never at the burner itself.

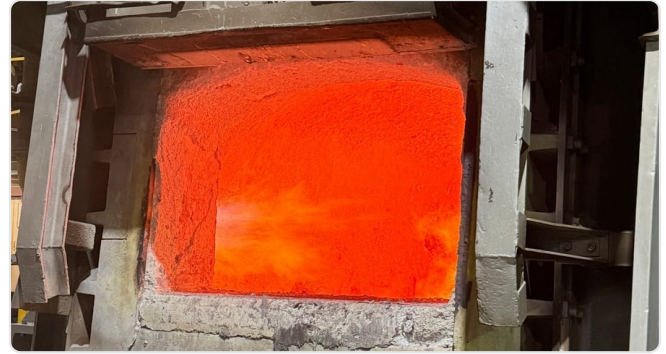
*Glowing lining in operation*
